## METAL / NONMETAL Serious Accident

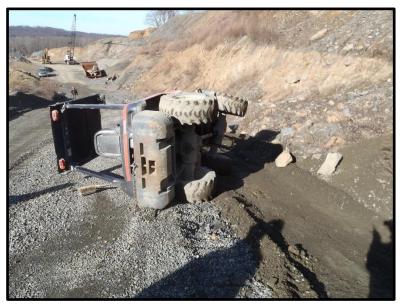
Surface Traprock — A loader operator was travelling down a 14% sloped roadway in a small articulated open-station loader which was equipped with ROPS and a seat belt. The operator was cleaning a shallow drainage ditch and rebuilding the washed-out berm behind the ditch. While watching the left side of the bucket and trying to maintain grade alignment with the roadway, a 1' by 1' by 2' rock slid between the right side of the bucket and the front tire. The operator did not see the rock and when the right front tire ran over the rock, it caused the loader to tip to the left. The loader landed on the left side in the roadway. The operator was wearing his seat belt and was not injured.

- Always be attentive to changes in ground conditions and visibility when operating machinery.
- Maintain control of self-propelled mobile equipment while it is in motion.
- Always wear a seat belt when operating mobile equipment.
- Task train mobile equipment operators adequately and ensure each operator can demonstrate proficiency in all phases of mobile equipment operation before performing work.
- Stay alert, stay awake, and pay attention to the task.
